San Francisco Creek Bridge

Emergency North Embankment Restoration Briefing with Stakeholders

March 23, 2023

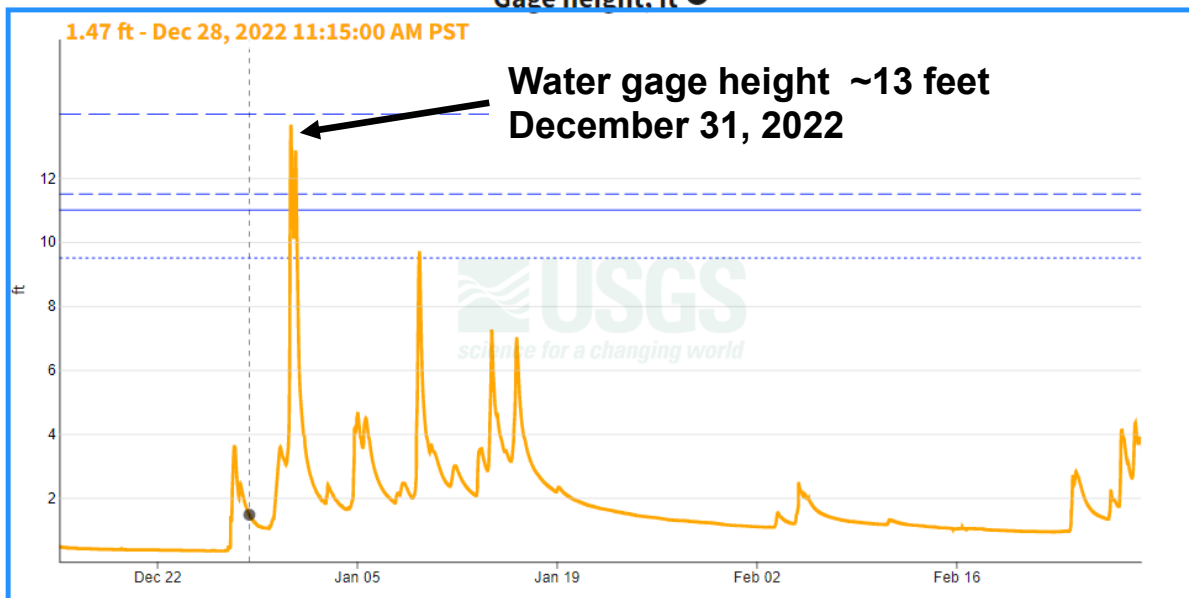
Winter Storm Events (2023)

December 15, 2022 - February 28, 2023

Gage height, ft ⓘ

Current: — Provisional
Action stage: - - - 9.5 ft
Minor flood stage: — 11 ft
Moderate flood stage: - - 11.5 ft
Major flood stage: — 14 ft

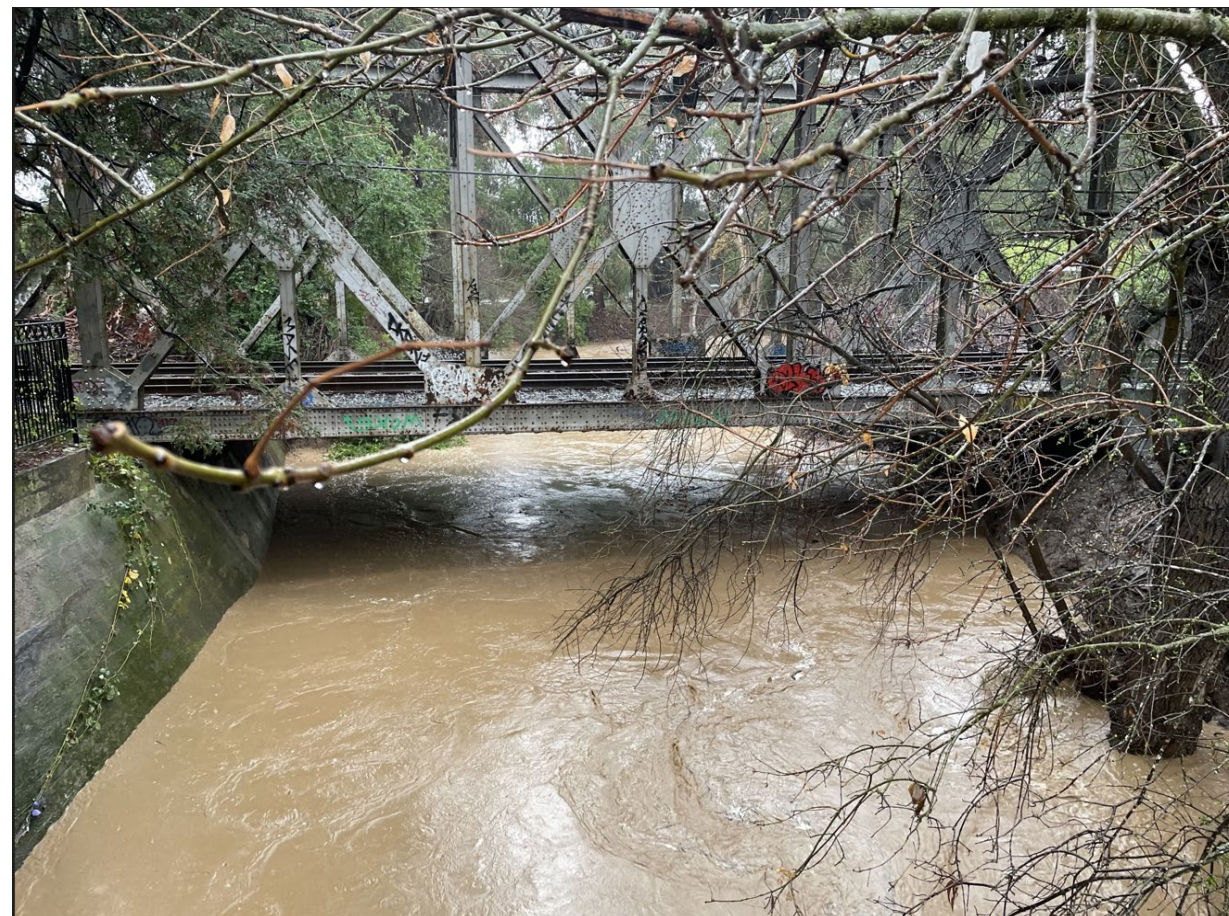
San Francisquito C a Stanford University CA

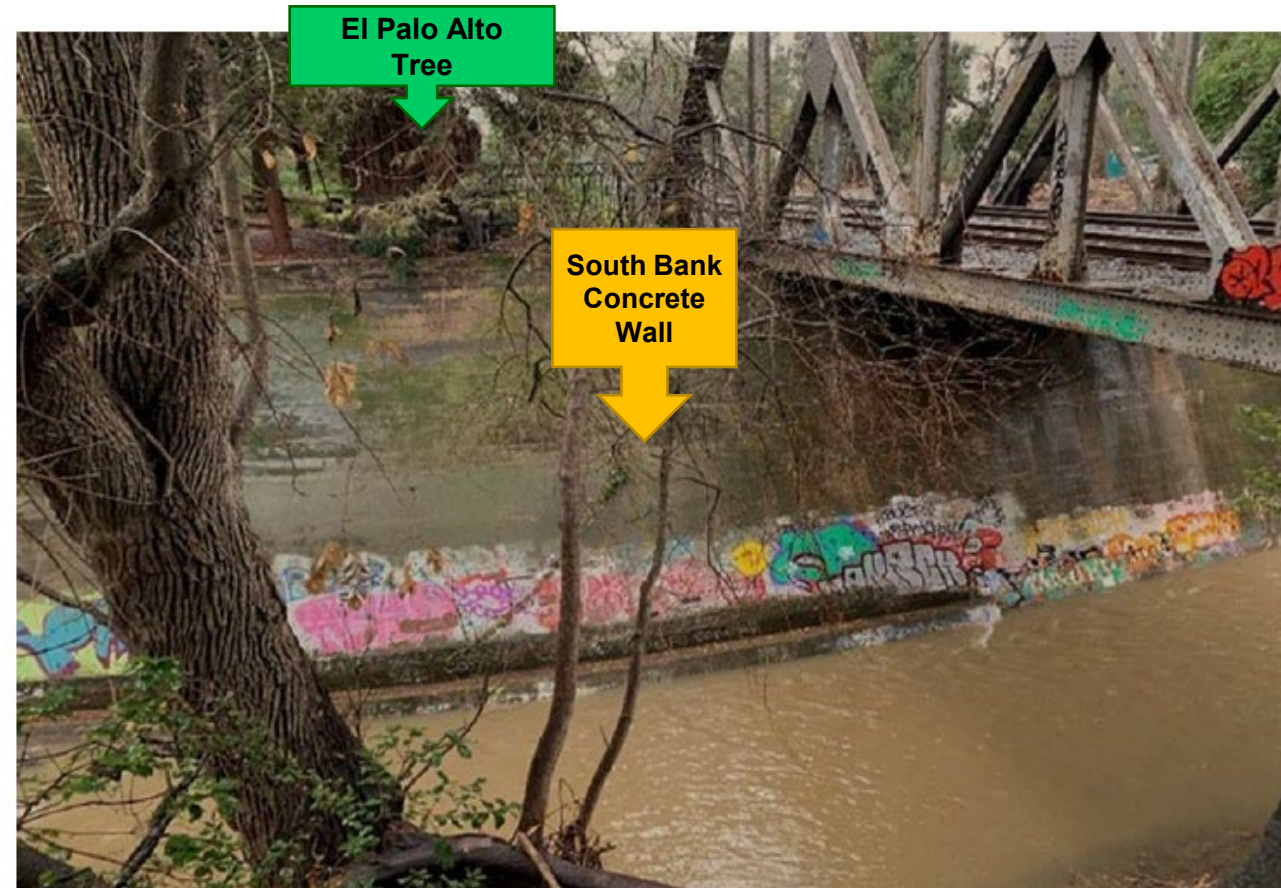
South Embankment

Post-storm site inspection South Embankment:

- Creek water elevation **has receded** after the storm event and measures 25-feet below the bridge soffit
- South bank below the railroad bridge bearings has **concrete wall** providing protection for both the abutment and **historic El Palo Alto Tree**
- **Moderate scour** has been observed at the toe of the concrete wall due to high water velocity

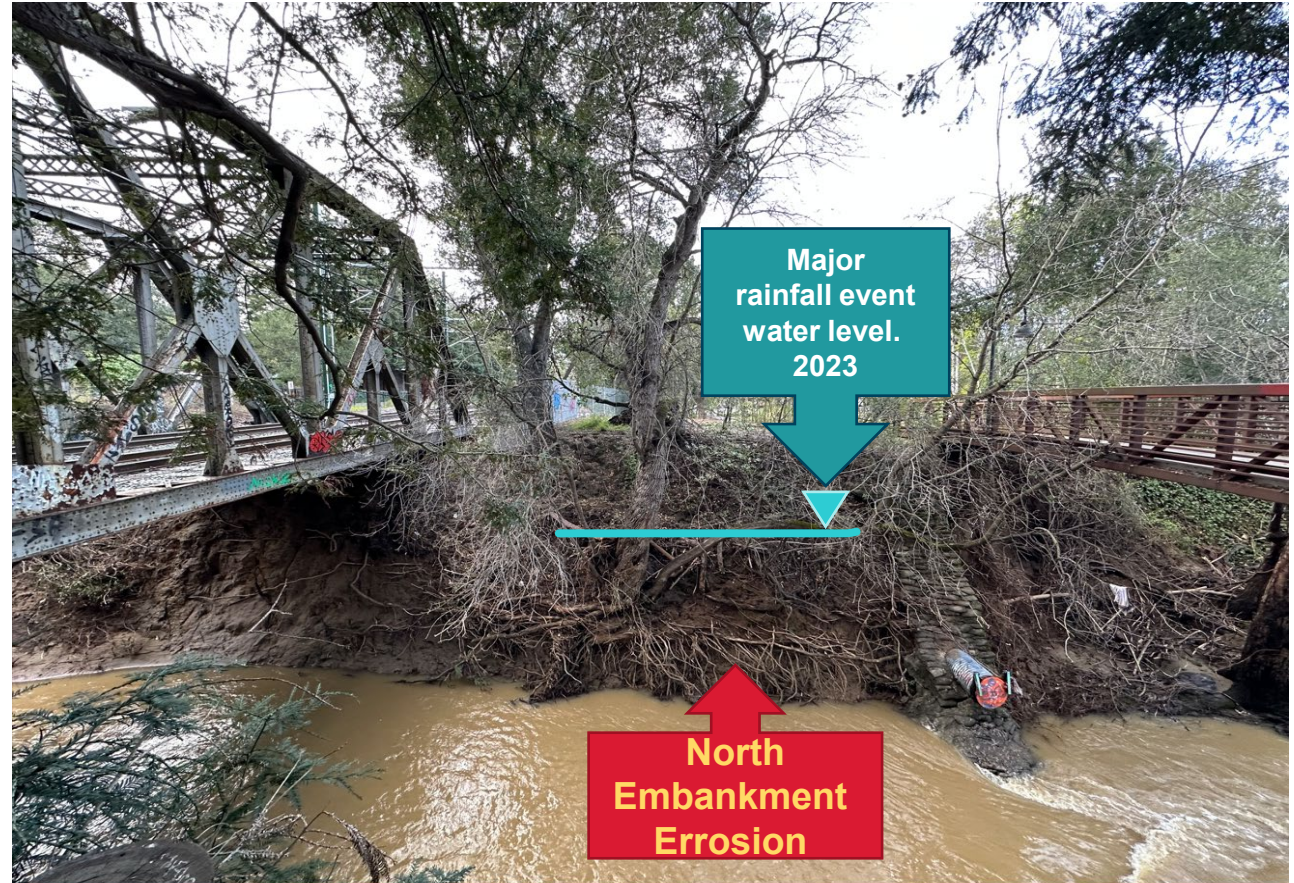
North Embankment Scour

Post-storm site inspection North Embankment:

- North bank abutment slope protection below **Caltrain's railroad bridge** has been **severely scoured** and **undermined** to a near vertical condition
- The adjacent slope embankment and large diameter **tree root mats** are showing signs of significant **erosion** and **scour**
- Current conditions **exceed 1.5 to 1** maximum for soil slope stability
- Soil will continue to **erode** and become **unstable** without mitigation

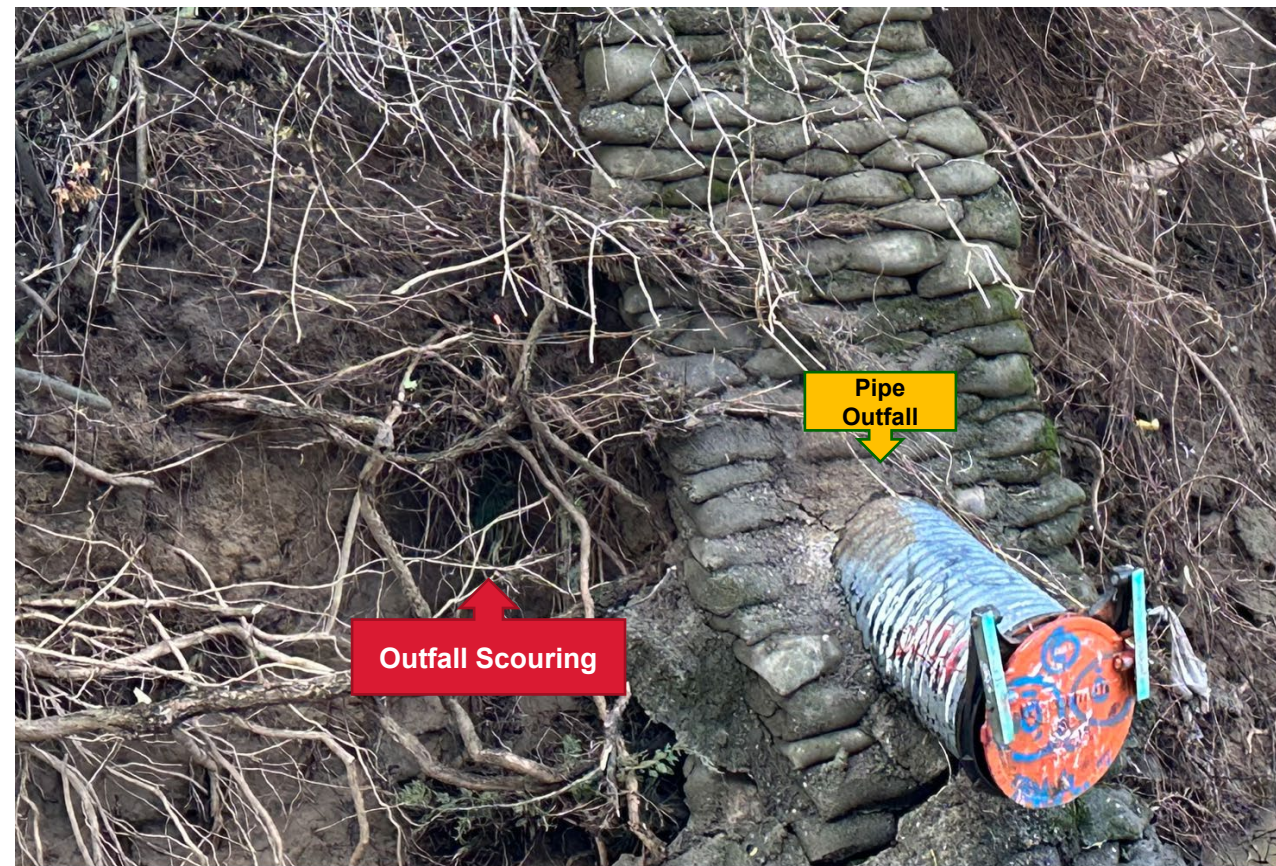
Outfall Embankment Scour

Post-storm site inspection North Embankment:

- Nearby storm **drainpipe outfall** from Palo Alto Park has also experienced **sever scour** and **embankment erosion**
- Outfall slope cement bags protection has **lost** supporting soil compromising the **structural integrity**

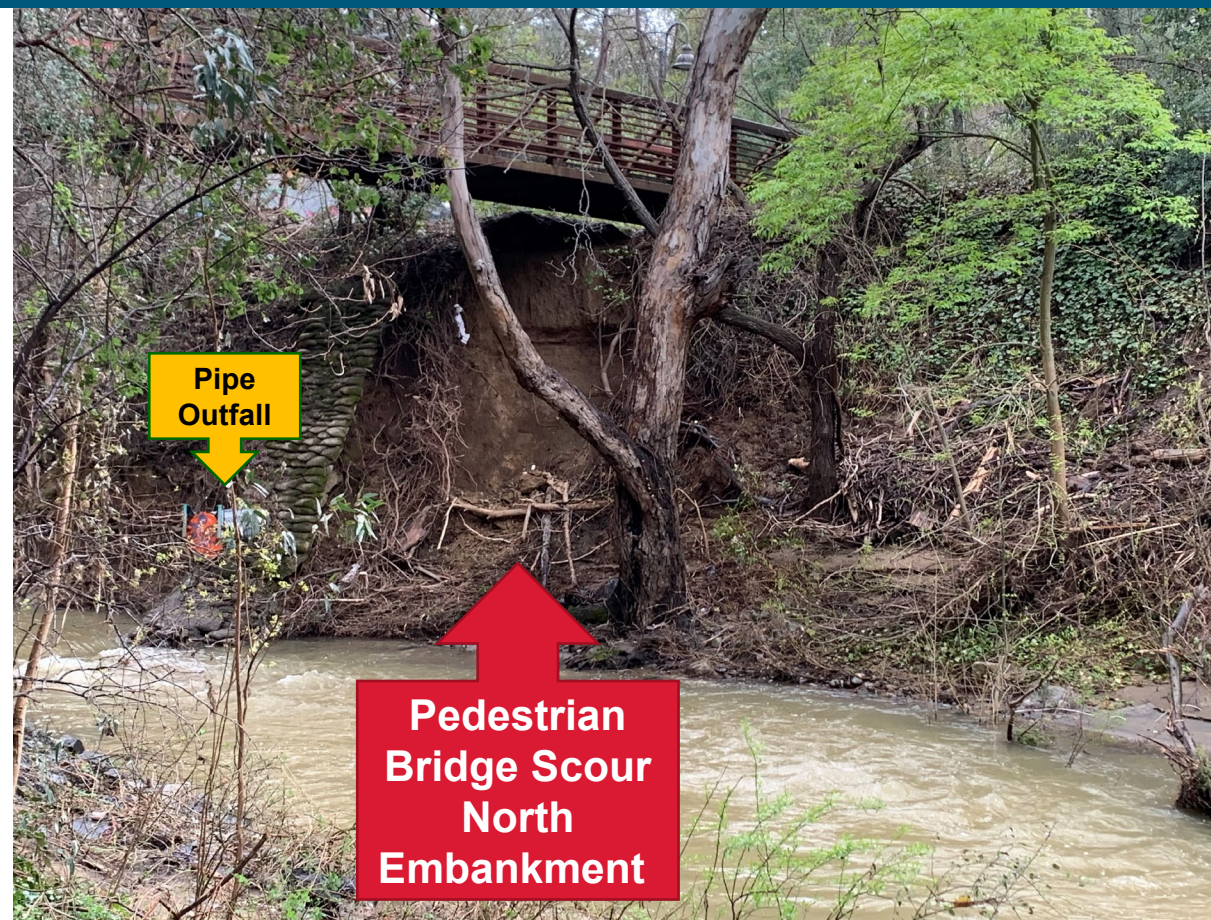
Pedestrian Bridge Embankment Scour

Post-storm site inspection North Embankment:

- Palo Alto Park's **pedestrian bridge** abutment slope protection has also been **severely scoured** and **undermined** to a near vertical condition
- Current conditions **exceed 1.5 to 1** maximum for soil slope stability
- Soil will continue to **erode** and become **unstable** without mitigation
- Caltrain will continue to coordinate with **Palo Alto** and **Menlo Park** regarding post storm conditions

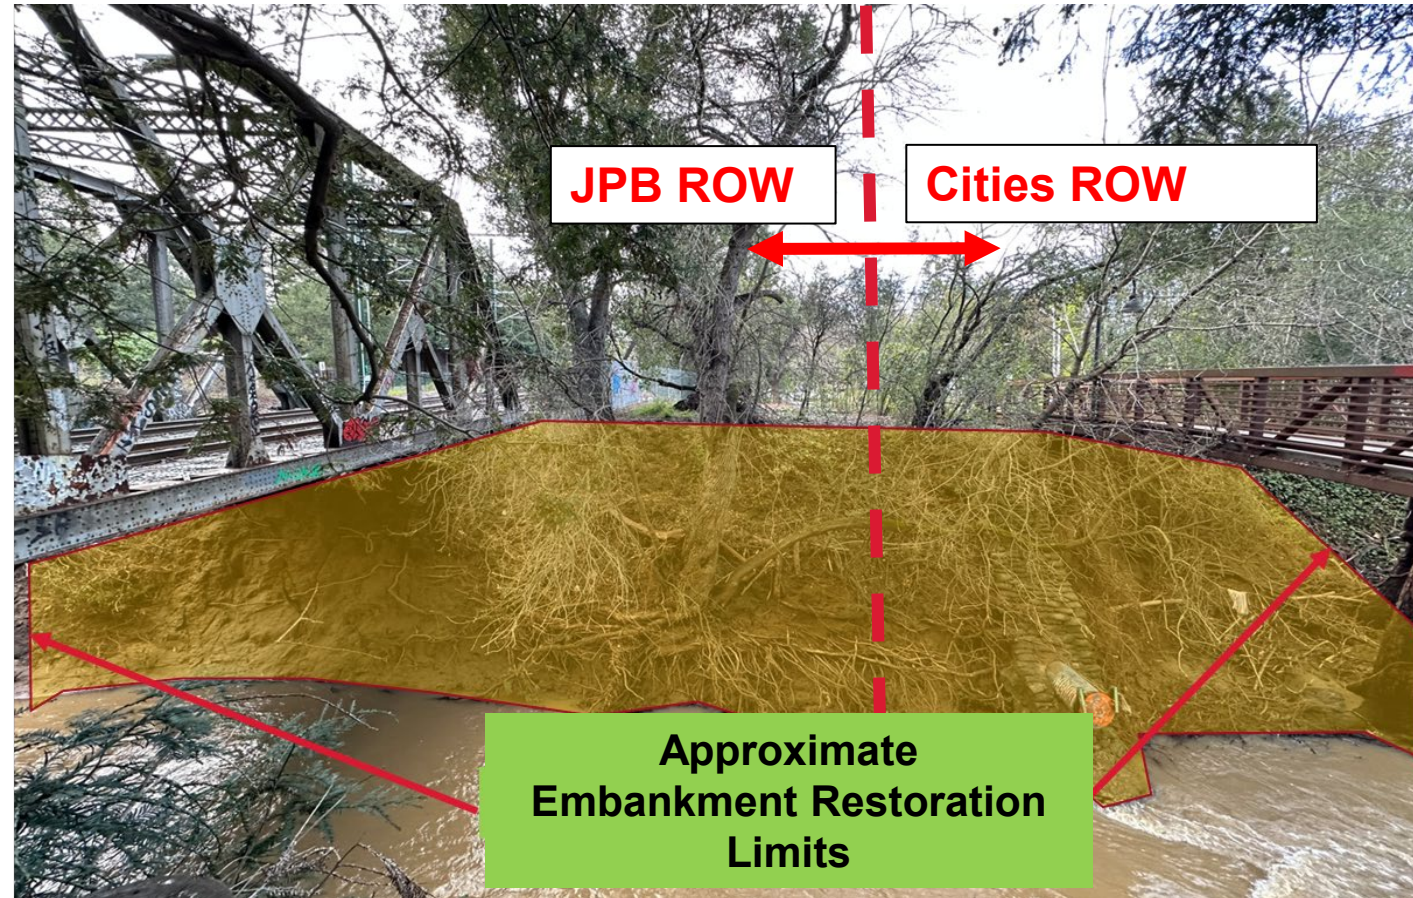
Embankment Restoration Limits

Project Restoration Limits:

- Approximate restoration **limits** from **east** of Caltrain's railroad bridge to **west** of Palo Alto's pedestrian bridge (shaded area)
- Embankment restoration **extent** and **method** subject to **hydraulic** modeling analysis and approval from the environmental **permitting agencies** and coordination with **adjacent property owners**
